NAVAL POSTGRADUATE SCHOOL

THE MITIGATION OF RADIO NOISE AND INTERFERENCE FROM ON-SITE SOURCES at RADIO RECEIVING SITES

November 2009

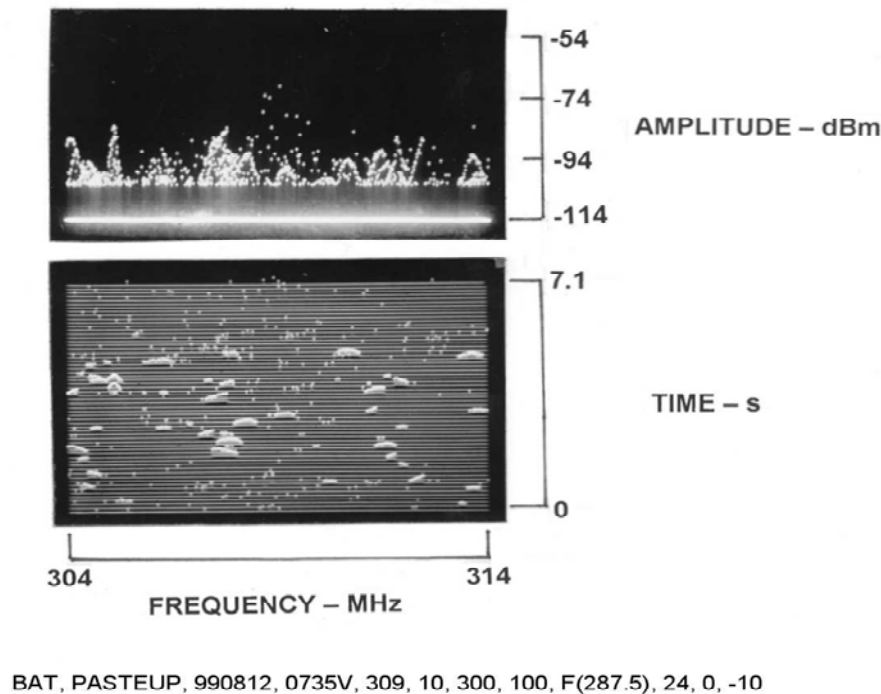
The previous Figure 7 shows one example where a strong signal about one-second in duration produced IM products and noise also about one-second in duration. Even shorter duration IM products and noise can occur, and Figure 9 shows an example. In this case a frequency-hopping transmitter emitting pulses in the low portion of the VHF band was operated adjacent to a receiving facility. Its strong VHF signals overloaded components in the RF path and produced high-level impulses of IM noise from 60 MHz up to 1000 MHz. Figure 8 shows an example of the resulting IM pulses in a 10-MHz wide portion of the radio spectrum centered at 309 MHz.

Figure 9 Intermodulation Pulses in the UHF band from a VHF Source

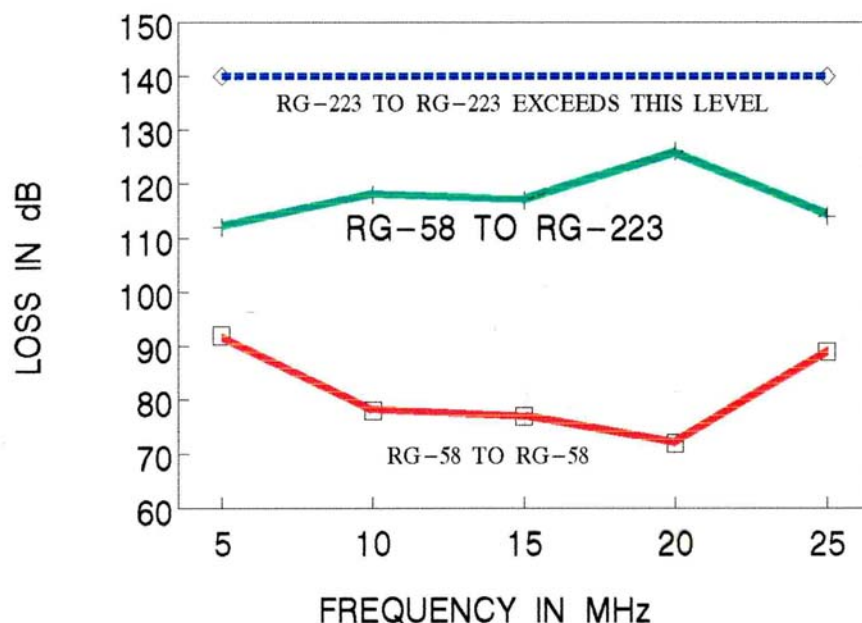
Figure 11 shows the result of this measurement where the leakage loss is expressed in dB. The single-shielded to single-shielded coaxial cable provided only about 70 dB of isolation near the center of the frequency range while the double-shielded to double-shielded loss was greater than 140 dB (not measurable with the test setup available). The single-shielded cable to single-shielded isolation is clearly insufficient to provide acceptable signal isolation from one antenna cable to another since at least 130 dB of cable-to-cable isolation is needed to avoid cross talk of received RF signals. The isolation provided by single-shielded to double-shielded cable also did not meet the needed isolation levels. Because of these findings only double-shielded coaxial cable should be used throughout a receiving site.

Figure 11 Cable-to-Cable Coupling Loss

To better understand the leakage of signals from one cable to another, two single-shielded cables (type RG-58) fifty feet long were run in a straight line along the earth. Two fifty-foot double-shielded cables (type RG-223) were added to the configuration.

Test signals were first injected into one of the single-shielded cables and then into one of the double-shielded cables. The far end of each driven cable was terminated in a fifty-Ohm coaxial terminator. The far ends of the un-driven cables were also terminated with 50-Ohm terminators, and the signal levels that leaked into the un-driven cables were measured with a spectrum analyzer at frequency intervals from 5 to 25 MHz.

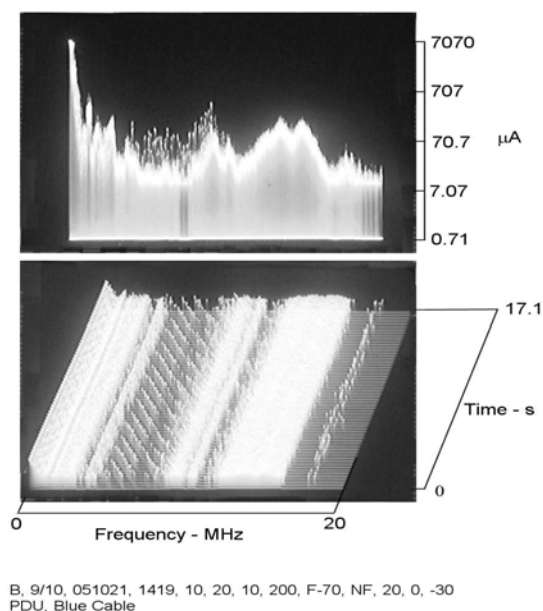
A few examples of excessive EMI current flowing on cables in a receiving site will demonstrate the problem. Figure 21 shows EMI current flowing on one of the 3-phase output power conductors of a Power Distribution Unit (PDU) over the frequency range of 100 kHz up to 10 MHz. This particular PDU was located within a shielded room that housed the RF-distribution equipment for an HF receiving site. The PDU contained a switching power supply for its electronics along with other digital control devices, and it provided electric power to all equipment located within the shielded room.

Figure 21 EMI Current Flowing on PDU Power Conductor

Severe peaks and nulls in noise amplitude were found across the entire frequency range of the data at levels significantly above the minimum tolerable level provided in Table 1. The slanting lines in the time-history view over the frequency range of about 3.5 to 8 MHz are from repetitive impulsive noise with a period of 8.3 ms (a pulse occurrence rate of 120 per second). The amplitude of these impulses is shown in the upper amplitude-vs.-frequency view. The noise in the remaining part of the HF band was a combination of impulsive noise at lower levels and closely-spaced spectral components related to harmonics of the power-line frequency and of the switching rate of the power-converter device.

The PDU was examined to determine if it was procured in accordance with the FCC Class B noise voltage rating. No label was found on the unit, a violation of the FCC rules. While the voltage level of noise was not measured in accordance with the FCC test procedures, the high noise current level clearly indicate this unit was either manufactured to the FCC Class A industrial noise requirement or the noise requirement was simply ignored.

An examination of the power-conversion devices contributing to the harmful levels of radio noise in Figures 21, 22 and 23 did not reveal the expected Class B or Class A labels required by the FCC for such devices marketed for general sale. Additional examination and measurements indicated that all were intended for industrial use rather than meeting the FCC Class B requirement for residential use. The use of such devices in and near a radio receiving site can significantly degrade the ability of a site to receive low-level radio signals of special interest, and they should not be installed in such facilities.

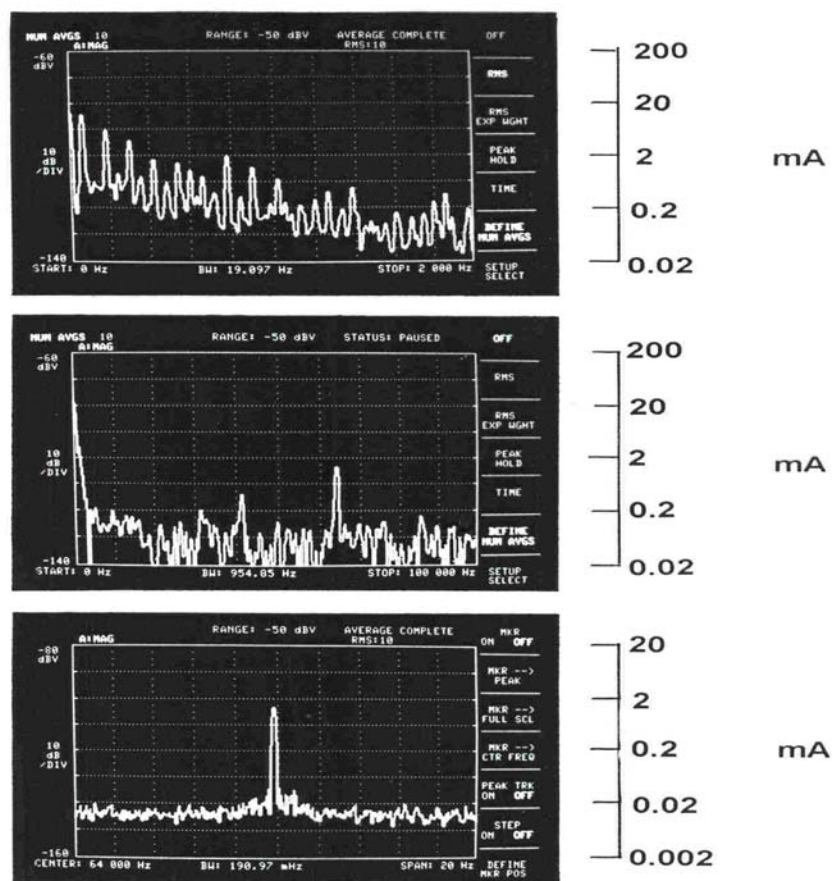
Significant levels of low-frequency current at the fundamental and harmonics of the electric-power frequency and at higher frequencies are found on ground buses, conduits, and other conductors of a building. Figure 28 shows three views of spectral components of current flowing on a green-wire ground from a cabinet containing digital devices. The top view shows current at the fundamental frequency and at harmonics over the frequency range of 0 to 2000 Hz. The middle view shows a coarse view of components over the frequency range of 0 to 100 kHz. The bottom view shows an expanded view of a strong component found at 64 kHz. Other cases have shown that 50- or 60-Hz levels as high as 8 A have been found flowing on conduits along with harmonic levels up to 1 A.

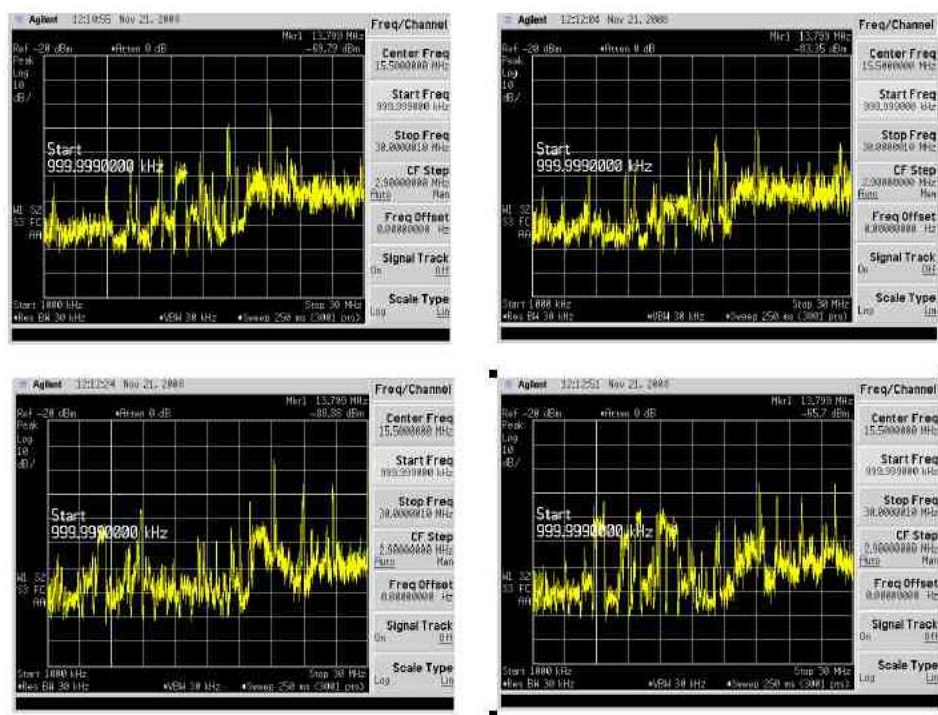
Figure 30 shows an example of erratic noise and interference found over the 1- to 20-MHz portion of the HF band at a receiving site where the data was obtained with a conventional scanning spectrum analyzer. Four sequential scans are shown where the spacing between the first two scans is about 20 seconds, and the spacing between the other examples is only a few seconds. A careful examination of the four examples shows significant differences in detail from one to the next one. The spectral and temporal properties of the noise and interference changed significantly from example to

example, and the changes cannot be understood from such sequential examples. These examples illustrate the difficulty in describing erratic noise and interference with standard instruments.

Figure 30 Example of Erratic Noise and Interference

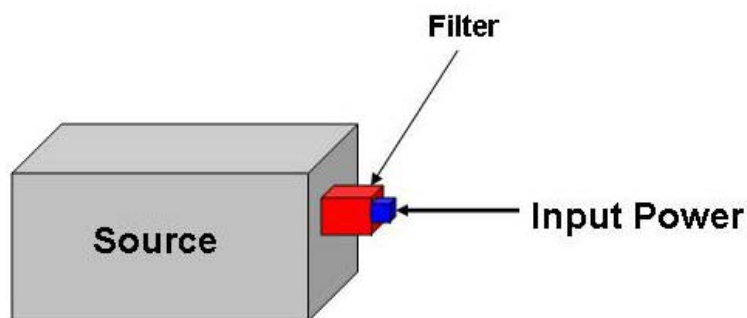
Figure 37 Provision of Power to a Source

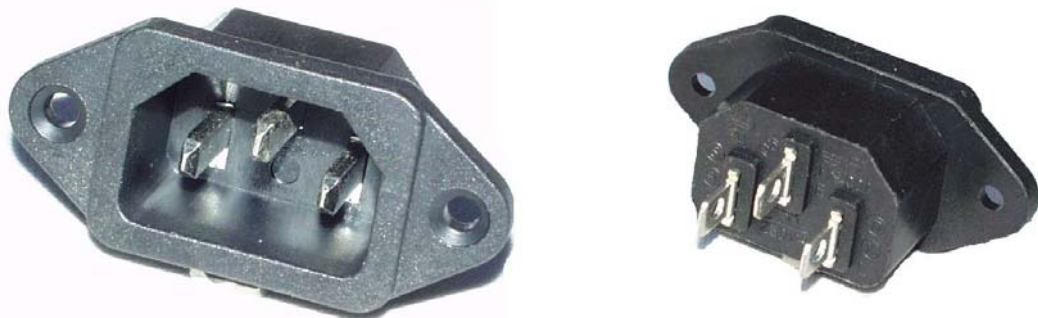
Figure 42 Chassis Power Connector that does not comply with BFG Needs

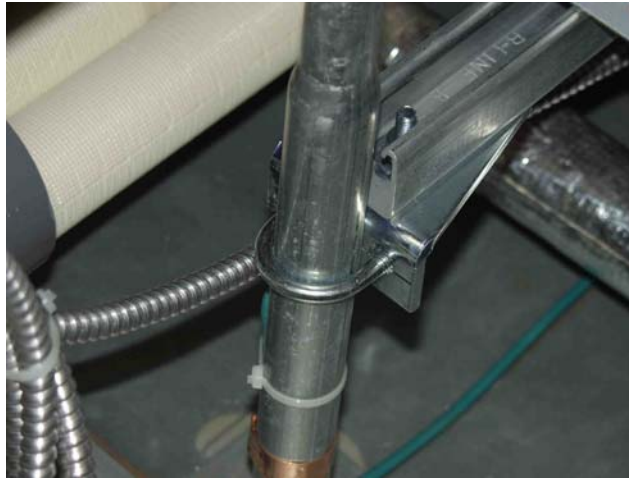
Figure 52 Incidental Contact, Example 1

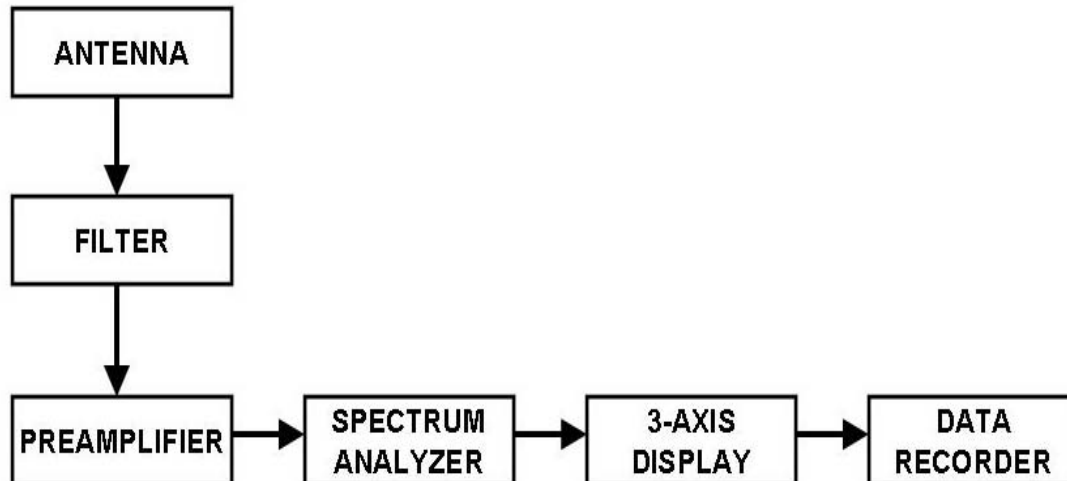
Figure 57 Block Diagram of the Instrumentation

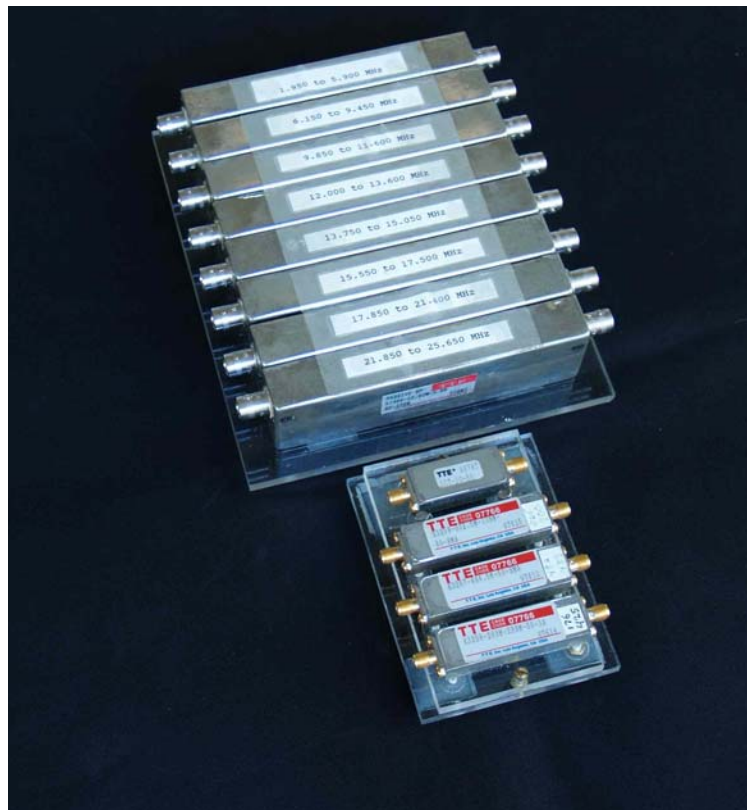
Figure 59 Example of Band-pass Filters

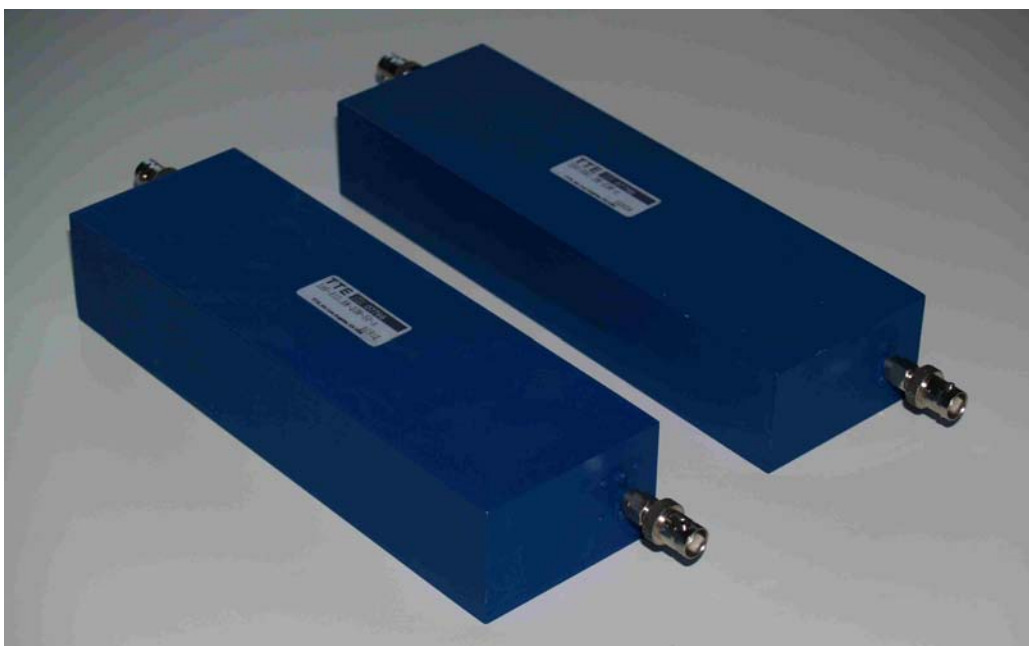
Figure 60 Example of Special Purpose Filters for the UHF Band
